# Distressed Properties: Community Risk Reduction in the City of Surrey

Larry Thomas, Mark Griffioen, and Chris Biantoro  
*September 2021*

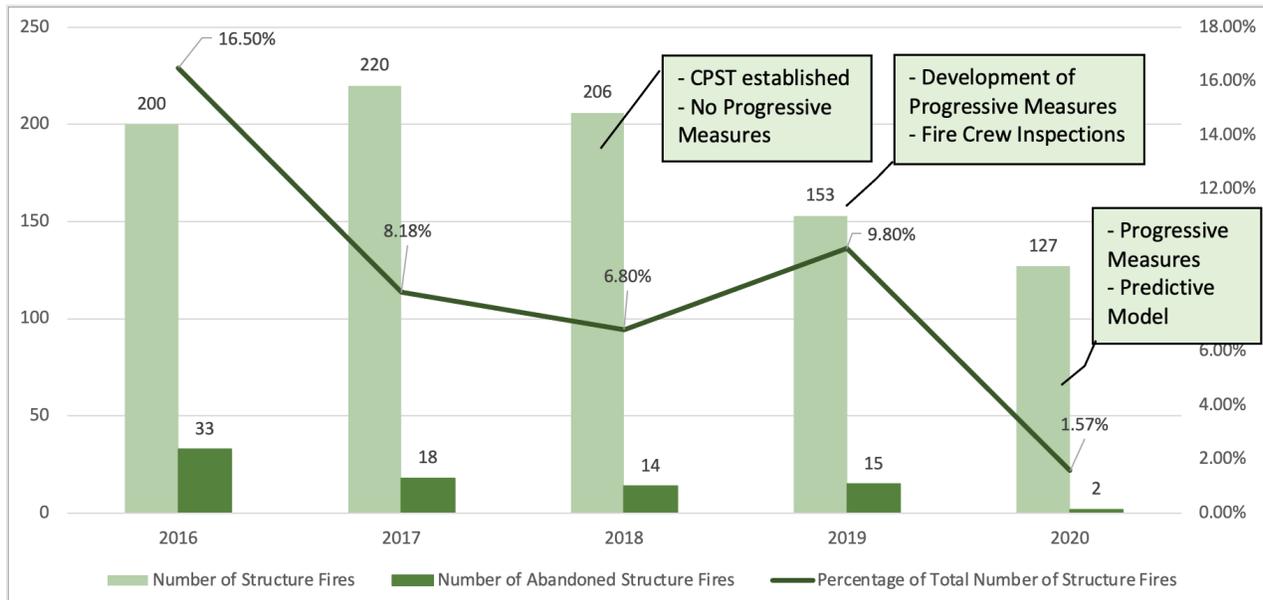
**Graph 1: Abandoned Structure Fires**

The upward trend between 2018 (14 fires and 6.8% of the total) and 2019 (15 fires and 9.8% of the total) took place while the CPST explored and developed new progressive security measures to deal with repeated unauthorized access at secured vacant properties. However, the combination of the new progressive security measures, the predictive model to identify vacant properties, and the automation in 2020 of the reporting of unauthorized property breaches led to the significant decline of abandoned structure fires in 2020.

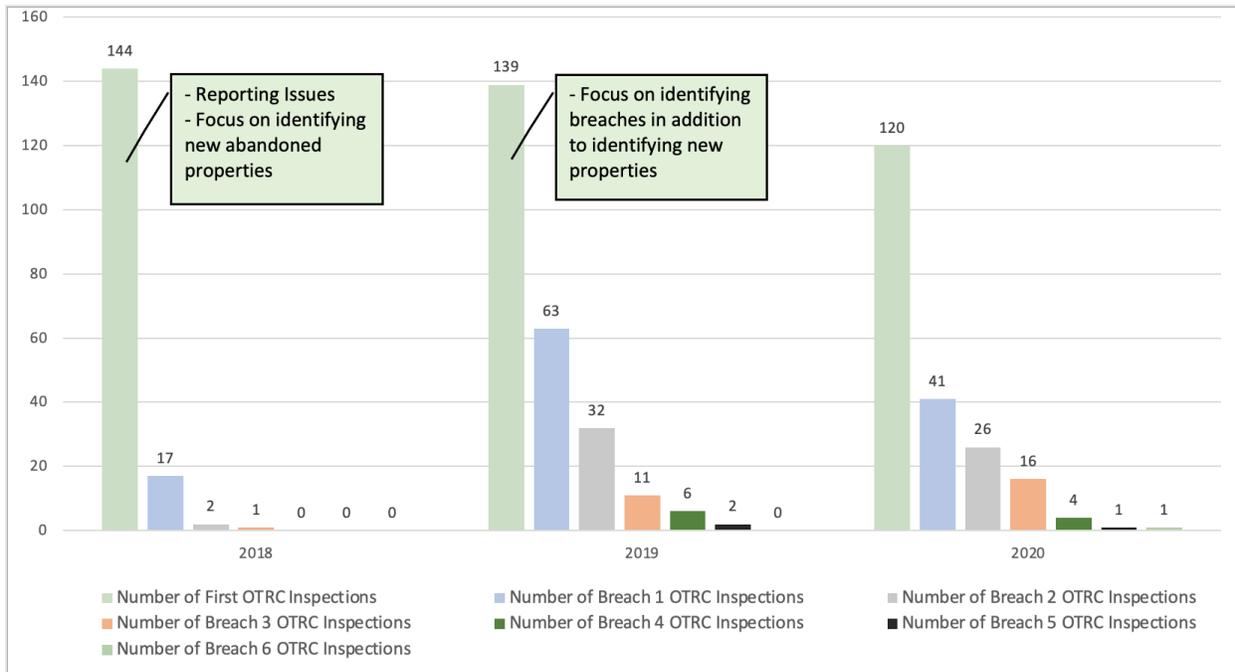
**Graph 2: First OTRC Inspection and Subsequent Breach Inspections**

The breach OTRC inspections resulted in 410 follow-up inspections by the CPST. Graph 2 shows the year 2018 with the least number of breaches, caused by data-reporting issues and the CPST’s focus on identifying new abandoned properties instead of monitoring breaches. In 2019, the focus shifted to not only identifying new abandoned properties, but also to monitoring breaches. This led to 2019 becoming the year with the most property breaches, followed by 2020. Nevertheless, Graph 2 also shows that fewer and fewer abandoned properties experienced additional breaches because of implementing progressive security measures.

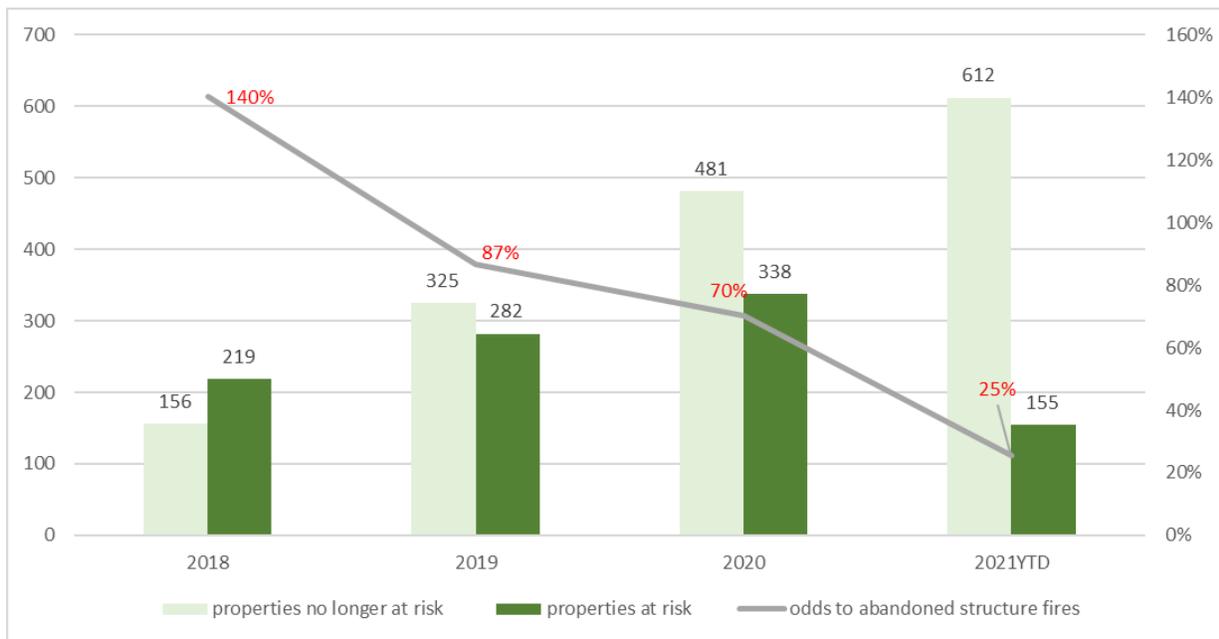
**Graph 3: Cumulative Number of Properties at Risk vs. No Longer at Risk**

Overall, the number of Surrey properties that no longer pose any risk due to demolition or reinvestment has been consistent with an average of 158 properties per year. This totals 612 properties that no longer pose risk as of June 2021 (see Graph 3).

As shown in the graph above, the program’s success at identifying new properties in 2020 and 2021 through use of predictive modeling has increased the inventory of properties at risk. However, the success of the progressive security measures, targeted inspections, and reporting by fire crews about unauthorized entries has reduced the odds (ratio) of structure fires taking place in these buildings. This has resulted in fewer abandoned structure fires in 2020 and 2021, as shown earlier in this report.

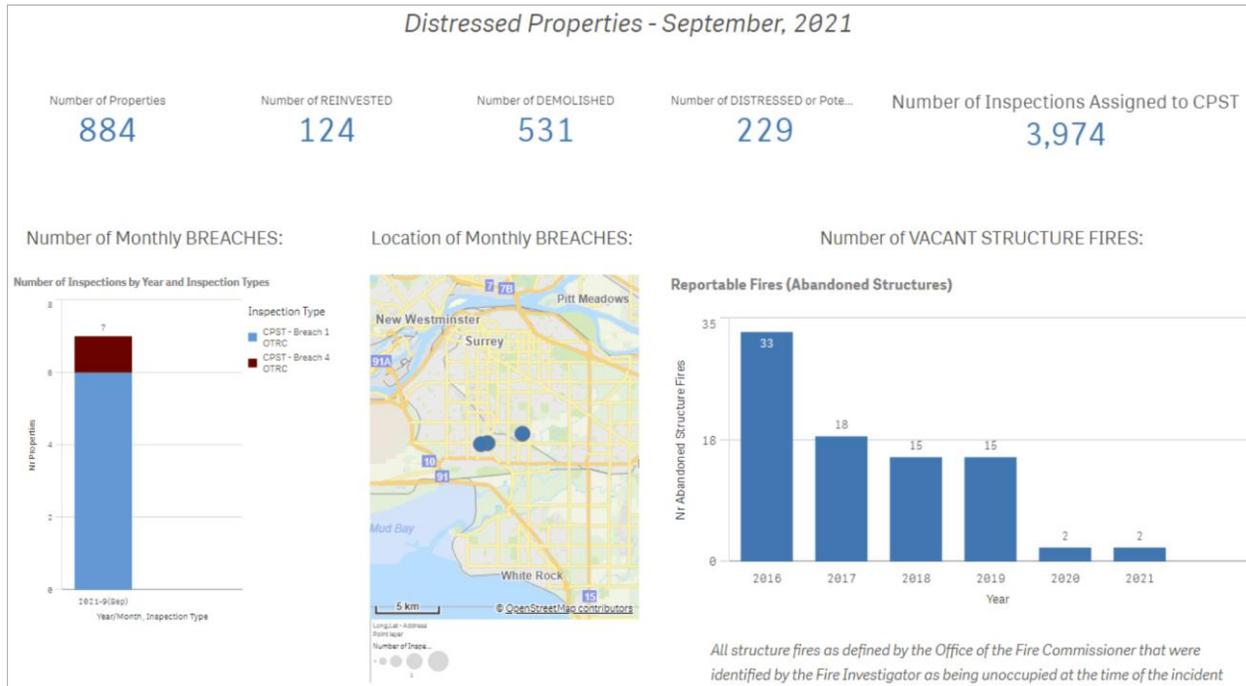
**Figure 3: Business Intelligence Dashboard Application to Monitor Program Outcomes**

The program outcomes are monitored from a business intelligence dashboard application that is updated daily with data from a record management system (see Figure 3). The dashboard application combines operation measures, such as number of inspections over time, with outcome measures, such as number of breaches, number of fires at abandoned structures, and number of properties with demolition and reinvestment statuses. The application is also equipped with a map to locate properties with fires and properties at risk.

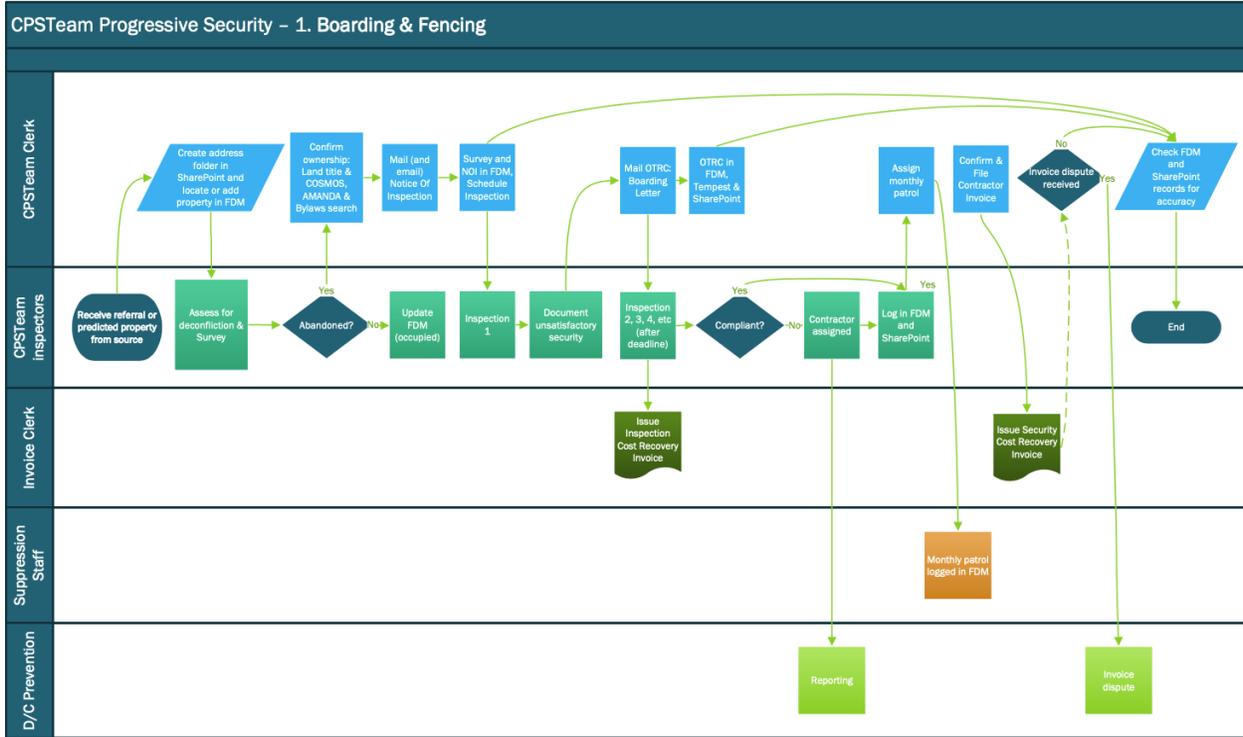
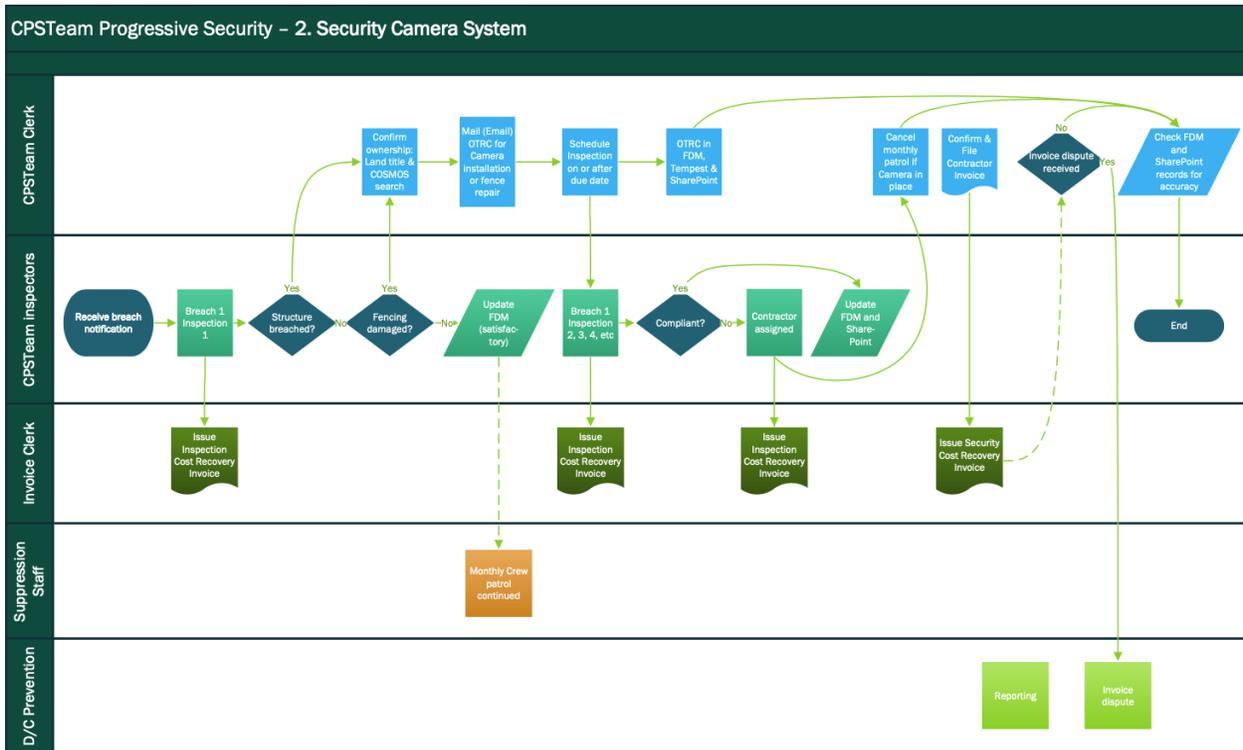
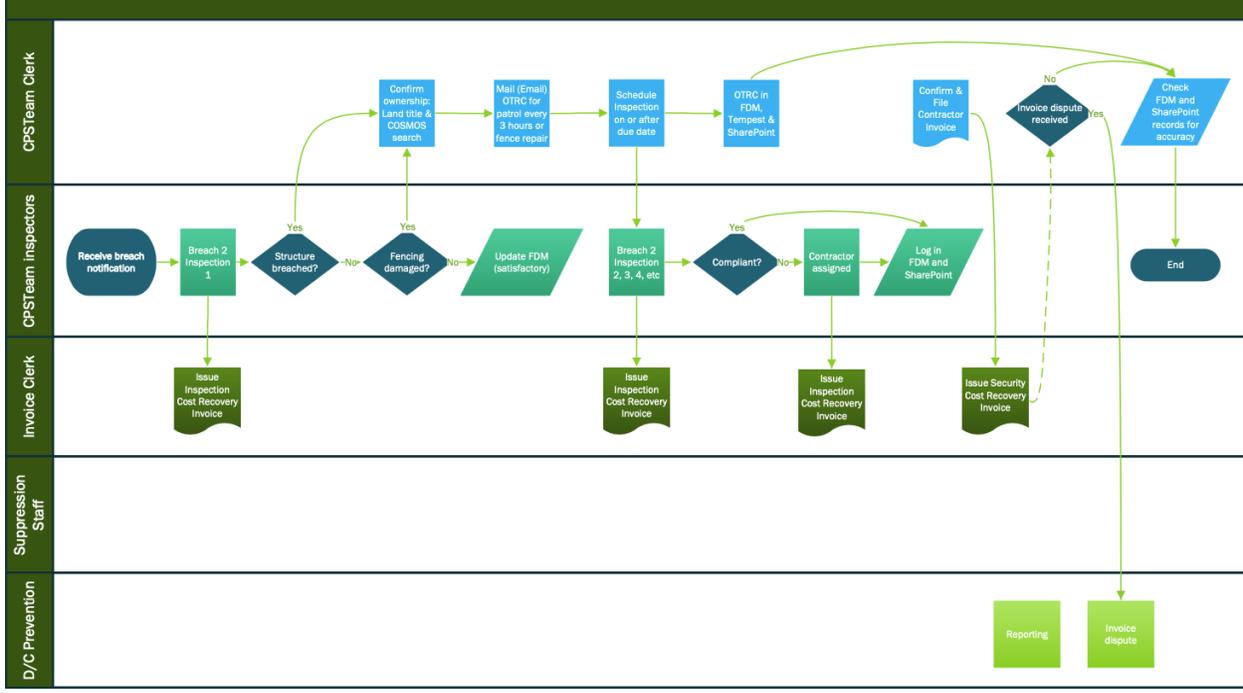
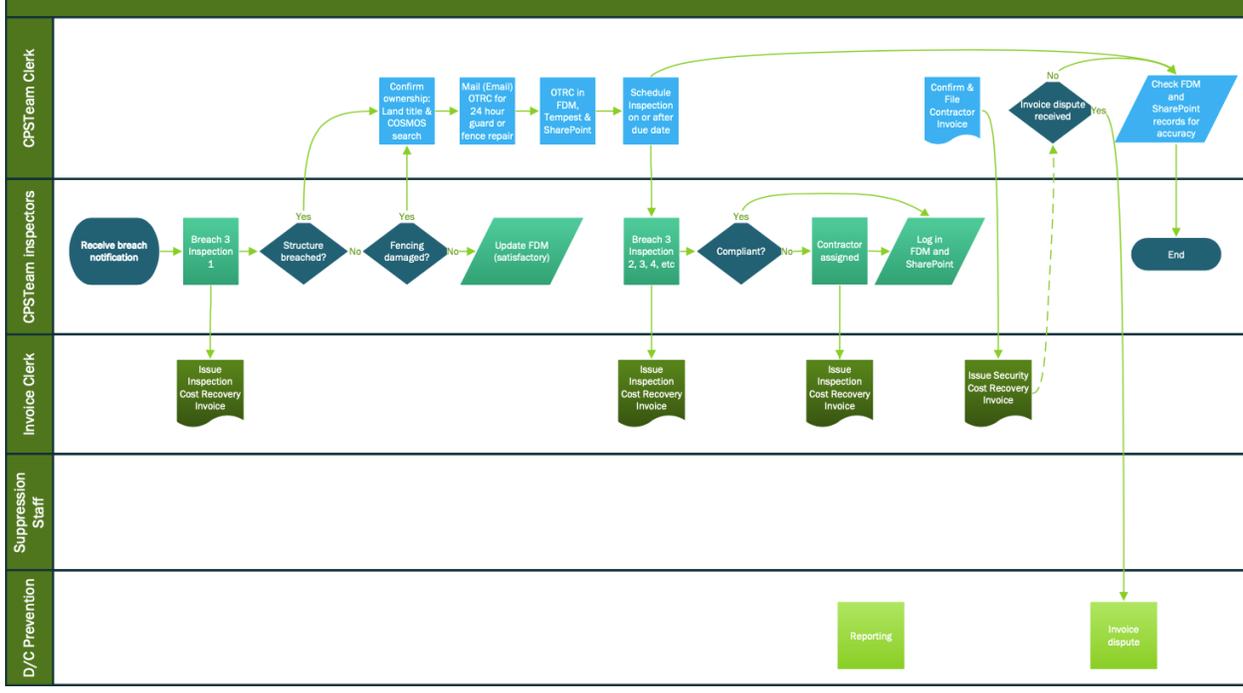
FIGURE 1: CPST PROGRESSIVE SECURITY FLOW

Monthly crew patrols monitor the owner's security measures, looking for vandalism, graffiti, litter on the property, illegal dumping, arson or forced entry, to determine if the chosen security methods in place are effective (see Figure 2). The escalating security requirements for sites with recurring issues is outlined below.

- If unauthorized entry takes place at a property secured by boarding and fencing, security requirements are increased to include a monitored security camera system with a security guard response. Monthly fire crew inspections are discontinued to avoid triggering the camera system.
- If unauthorized entry takes place despite a monitored security camera, a live security patrol no less than once every three hours is required.
- If unauthorized entry continues, a full-time live on-site security guard service is required.
- If unauthorized entry continues, additional full-time guards are required.
